BioMAP Report SWR-3

Ministry of Environment and Energy

ENVIRONMENTAL ASSESSMENT OF MILL CREEK IN THE VICINITY OF THE PORT ELGIN LANDFILL SITE, BRUCE COUNTY

June 1994

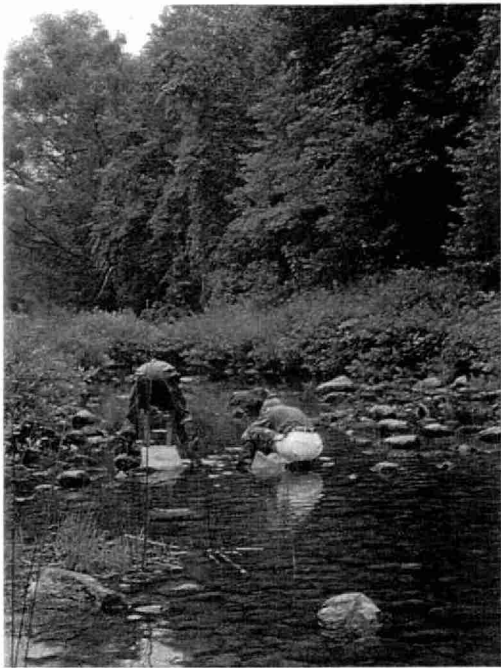
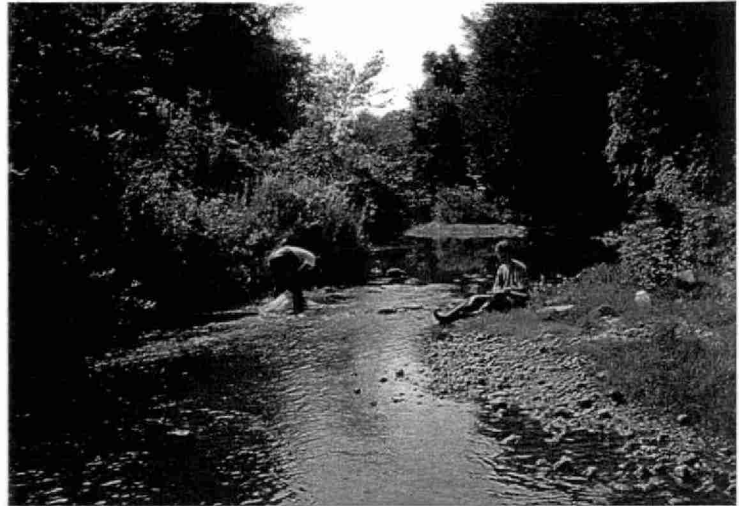
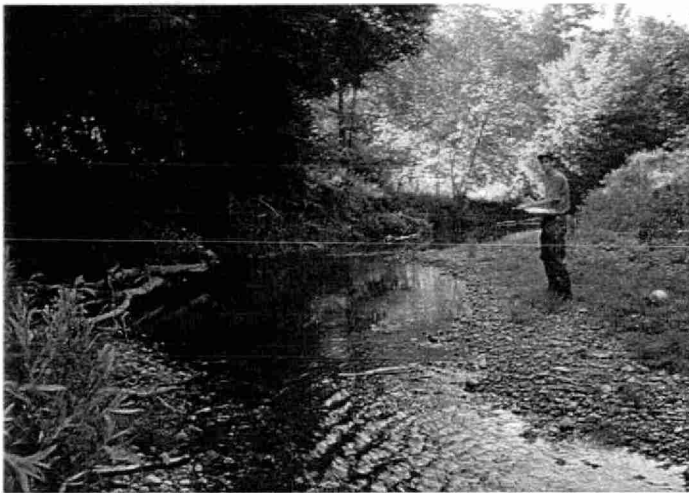
Figure 2: Pictures of sampling sites 1, 2, and 3 along Mill Creek.

At Site 1, located upstream of the County Road #17 bridge (Figures 1 & 2), the substrate was composed of small boulders, cobble, gravel and sand (Figure 3). Sparse moss and diatom growth covered the cobble. Marl (travertine) was deposited over the larger cobble, likely associated with the growth of mosses and algae (e.g. diatoms). At Site 2, the substrate was composed of cobble, gravel and sand (Figure 2). The filamentous green alga, *Cladophora*, covered approximately 60% of the riffle area, but the fronds (filament length) were only a few centimetres long. A beaver was completing a dam approximately 150 m upstream. At Site 3, the

substrate was composed of small cobble, gravel and sand (Figure 2). Pronounced iron staining (orange colour) was noted over portions of the substrate. Riffle areas were about 60% covered with *Cladophora* stubble. *Spyrogyra* was common in even-flow areas, beginning downstream of Site 2 and continuing downstream of Site 3 (Figure 3).

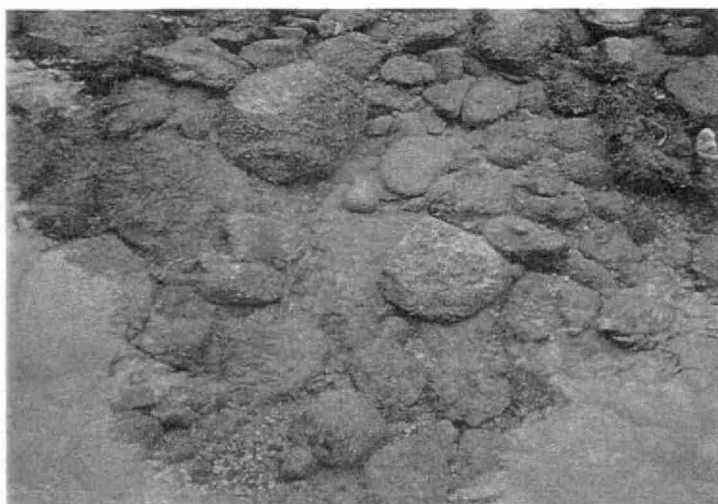
Figure 3: Pictures of the stream bottom at Site 1 (upper) and filamentous algae between sites 2 and 3 along Mill Creek.

The noticeable growth of filamentous green algae downstream of Site 2, however, suggests that the leachate may have a localized nutrient enrichment effect on the stream ecosystem. Ammonia concentrations ranging up to 13 mg/L have been measured in water samples from observation wells near the creek during the late 1980's (Morrison Beatty 1991). The average ammonia concentration in the groundwater near the creek was estimated to be 0.2 mg/L in 1993 (Dames and Moore, Canada Limited 1994), about an order of magnitude greater than that measured in the creek (Table 1). Similar growth of filamentous green algae has been observed in the Bighead River adjacent to the Meaford landfill site (Griffiths, personal observation), in the Rocky Saugeen River adjacent to a landfill site near Markdale (Westwood, personal observation), and in the Middle Thames River downstream of a rendering facility that infiltrated ammonia-enriched wastewaters adjacent to the river (Griffiths, personal observation).

The occurrence of filamentous algae at sites 2 and 3 probably accounts for many of the differences observed in the community structure of the benthic fauna relative to Site 1. Filamentous algae is a food resource to some macroinvertebrates, provides food resources in the form of periphyton, growing on the stands of the filamentous algae, and organic matter filtered from the stream for others, provides attachment surfaces for filter-feeders, increases habitat heterogeneity by slowing currents, trapping detritus, blocking light, altering dissolved oxygen concentrations and daily pattern, and excludes some taxa by occupying attachment sites (Dudley et al. 1986). The higher abundance of baetid and heptagenid mayflies and lumbriculid worms at sites 2 and 3 probably reflects the increased availability of periphyton and organic matter provided by
